A LOW-COST SOLUTION TO A SECURITY VULNERABILITY IN FEDERAL BUILDINGS

2 COMPREHENSIVE BLAST TEST REPORT FOR THE U.S. DEPARTMENT OF INTERIOR

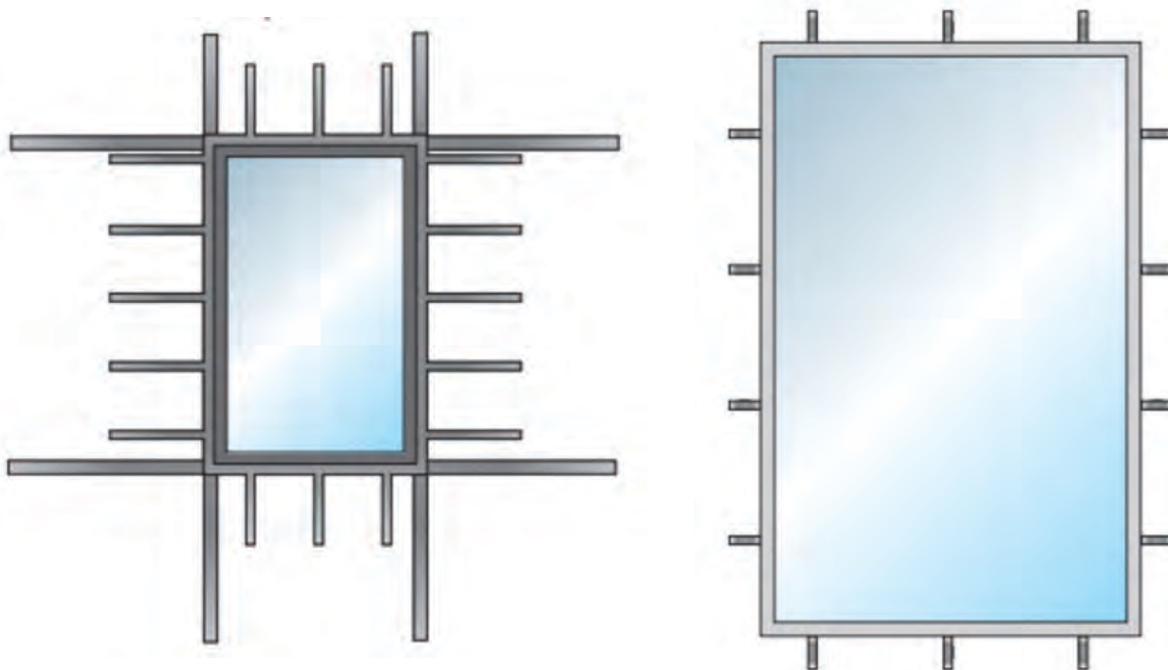
The image on the left shows a traditional blast window with heavy steel support beams. Thermolite's unique blast window system utilizes a specially designed flexible frame that absorbs blast pressure and eliminates the need for steel reinforcement.

Thermolite offers the only bomb blast window system made in the U.S. that uses dynamic loading to *absorb* a blast impact and prevent glass from shattering into the building. Traditional replacement windows require costly, labor-intensive structural steel reinforcements that serve to withstand the impact of an explosion via resistance. Thermolite blast windows, on the other hand, feature compression release technology and a balanced design that controls how blast energy is *transferred* from the glass to the frame, the frame to the wall, and the wall to the building. Thermolite blast windows utilize a patented frame design that absorbs the last pressure transfer until the negative phase of the pressure wave occurs.

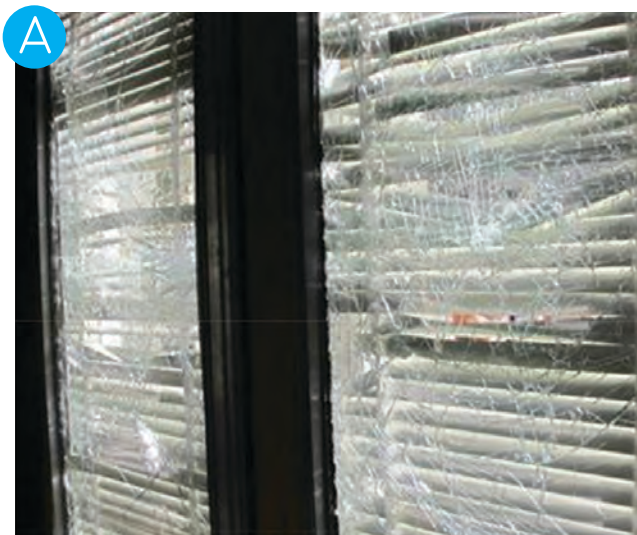
The Thermolite blast window remained intact after the test explosion

The blast test took place in Socorro, New Mexico. A 600lb ANFO explosive charge was detonated outside the replica, which had been fitted with Thermolite's interior blast window system. EMRTC reported that the internal window cracked, but retained in the frame and emitted no glass inside the structure other than a slight dusting. There were no indentations, penetrations or marks on the witness panel, and no glass fragments were found inside the structure with a united dimension of 1-inch or greater.

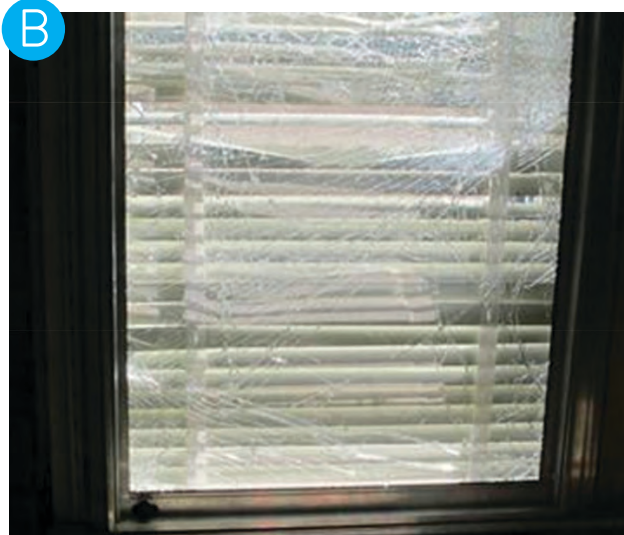
Another image showing the Thermolite window after the test explosion

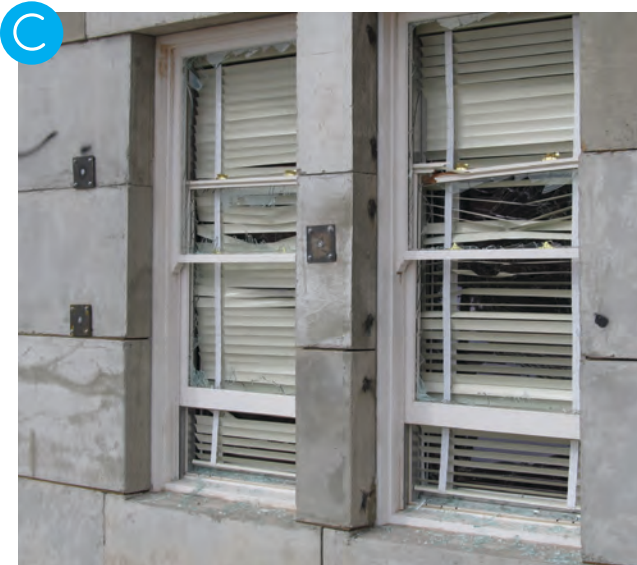
This image shows the exterior post-test window unit

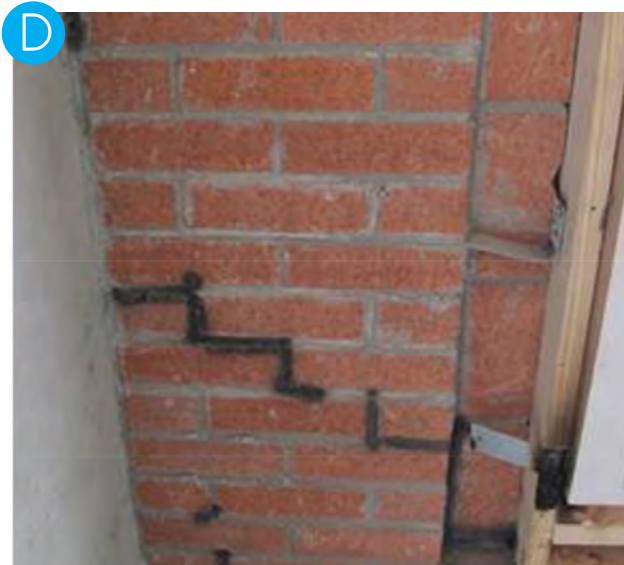
The test blast caused visible cracks in the masonry of the wall unit
